Bioremediation of creosote-contaminated soil in South Africa by land farming

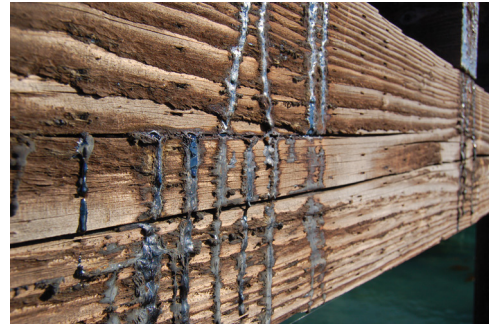
Online Case Study 6 Figure A Creosote-treated timber left to dry in treatment yards drip creosote and lead to contaminated soils and groundwater.

A number of sites in South Africa with varying levels of contamination in the groundwater and soil were identified in the early 1990s (Pearce et al., 1995). This included creosote-contaminated soils. **Creosotes** are chemicals formed from the distillation of tar. They are the most widely used preservative for treating structural timber that will be exposed to the elements, including railway cross ties, pylons, telegraph poles, and fencing timbers. A major source of pollution comes from the dripping of creosote-treated timbers that are left in the open air to dry (Figure A).
